Defects in Nonceramic Insulators: Can They be Detected in a Timely Manner?

*S. Gorur and S. Sivasubramaniyam Department of Electrical Engineering,
Arizona State University, Tempe, AZ, USA*

Transmission Line Insulator Condition Monitoring

Effect of Corona on Nonceramic Insulator Housing Materials

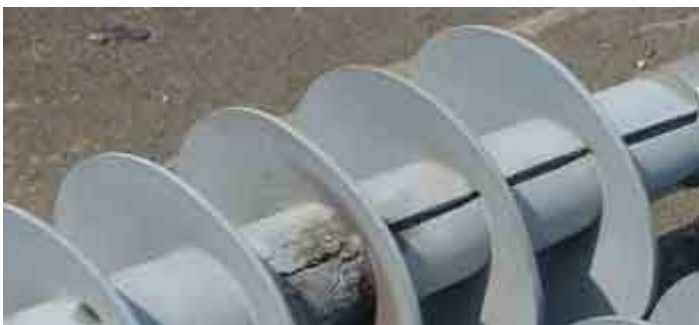
Fig.1: NCI Line Post that was removed from service in Southern USA

The presence of corona at the interfaces leads to sheath damage exposing the fiberglass rod, tracking the rod, thereby leading to insulator failure through interfacial flashover, rod burning and brittle fracture. Also, the presence of any contamination like water, salts, and dirt can intensify the field at those locations. Fig. 1 shows a picture of a failed NCI. It can be seen that the first few sheds have suffered corona cutting. Some degradation in the form of tracking and erosion is also visible. If the damage to the insulator is not in the line of sight, then this may not be identified as a problem during routine line inspection by road or helicopter patrols until the unit fails. The challenge is to identify such insulators at an early stage of degradation when there is still time to act.

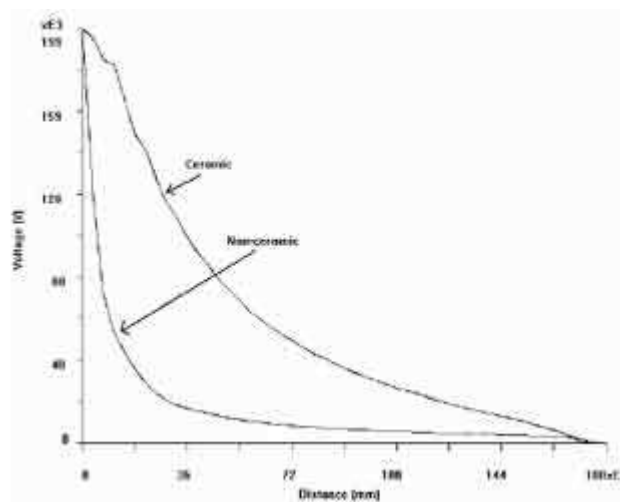
Fig.2: Significant difference in the voltage distribution exists between ceramic and NCI due to differences in construction. The insulator modeled is a 345 kV insulator

usually a problem in ceramic insulators. However in NCI's the voltage distribution is highly non-uniform as shown in Fig. 2, and can give rise to corona. Corona rings are normally used for NCI at voltages above 230 kV in order to reduce the electric field near the line end.

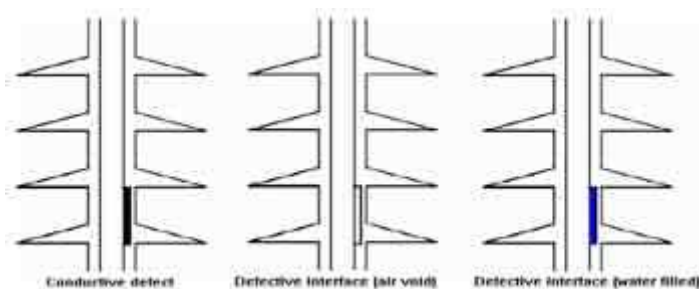
Fig.3: Diagrammatic representations of various types of defects modeled. A defect of 1 shed spacing is taken as the minimum length of the defect. The length of the defects were increased to span 2 and 3 sheds

visual inspection. However, defects that occur inside the housing are not visible. Hence such defects are modeled for electric field distortion studies to verify the possibility of detecting such defects using field probes as shown in Table 1. A defect that occurs for the distance between any two consecutive sheds is named as the single shed defect. A single shed defect will have the shape of a cylinder with a 9.2 cm height and 5 mm diameter. A diagrammatic representation of various types of single shed defects modeled is as shown in Fig. 3. Similarly two-shed and three shed defects are simulated and analyzed.

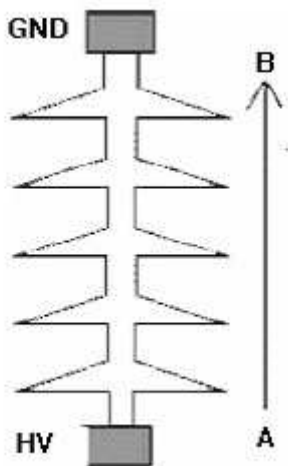
Fig.4: Measurement along insulator surface from location A to B. The line AB is about 2 mm away from the tip of the shed to permit probe movement

The field calculations are performed on the insulator along the axis as indicated by the path AB in Fig. 4. A distance of 2mm is assumed for the air gap in order to slide the probe on the insulator. The values obtained are compared with that of a healthy insulator and the change in field value is plotted against the shed number. The data for a defect of lengths equal to 1 shed spacing and 2 shed spacing are shown in Figs. 5 and 6.

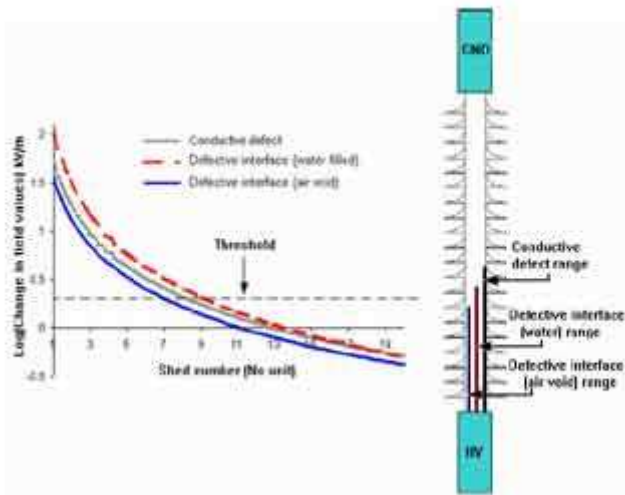
Fig.5: Range of detectability for defects that of length= 1 X shed spacing. Probe is assumed to me in the axial direction AB

It can be seen that the possibility of detecting defects in close proximity to the HV electrode is good, irrespective of the defect type. However, should the location be towards the middle of the insulator or towards the ground end, their chances of being detected is small or zero.

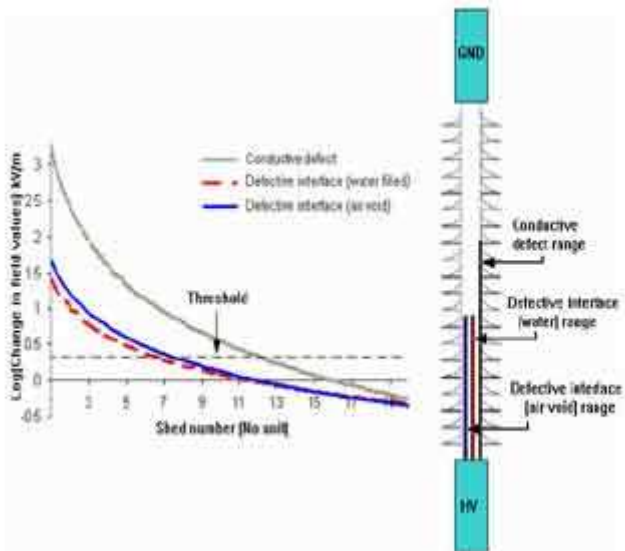
Fig. 6: Range of detectability for defects that of length= 2Xshed spacing. Probe is assumed to me in the axial direction AB

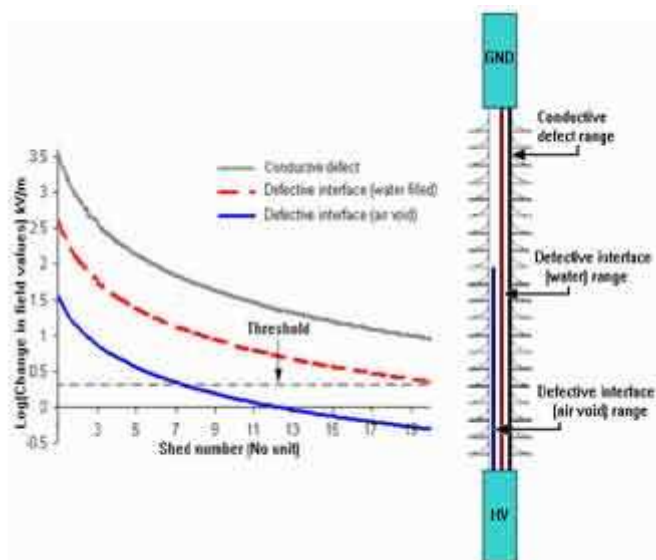
Fig.8: Range of detectability for defects that of length= 1 X shed spacing. Probe is assumed to be in the radial direction and is closest to point C

The range of the field probe can be greatly enhanced if measurements are taken radially instead of conventional axial measurements.

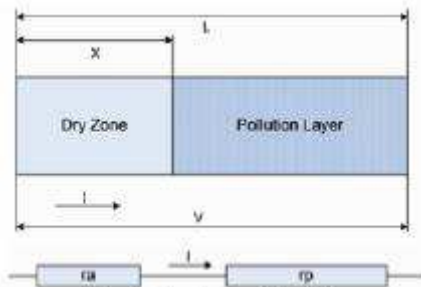
Figure 3 Simplified equivalent circuit

There are many mathematical models for pollution modeling that may be used to study insulator performance. A simple model [9] for the flashover process of a polluted insulator is a conducting pollution layer in series with a partial arc spanning a dry band region. Where (ra) is the resistance per unit length of the arc and (rp) is the resistance per unit length of the pollution layer, the expression for the voltage applied across the insulator is

$$V = I * (ra * x + rp * (L-x)) \quad (1)$$

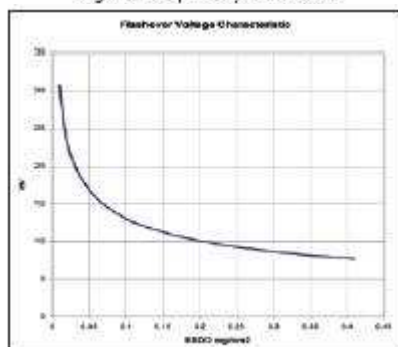
Figure 4 Insulator flashover characteristic

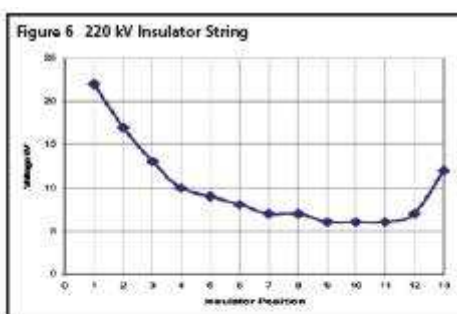
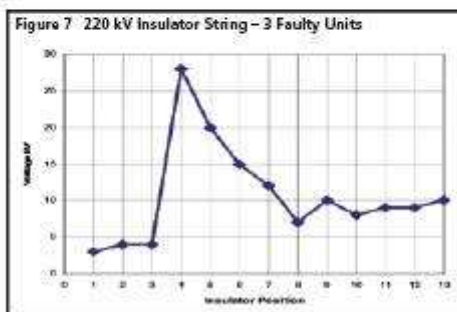
measurements across each insulator live I (see Figure 6 and Figure 7). Resistance measurement (Megger) of each insulator de- ii energised. Electric field measurement near each live insulator. iii

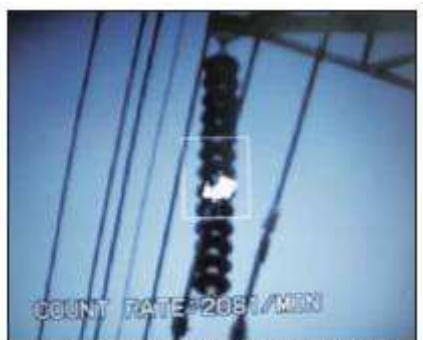
Figure 8 Corona caused by adjacent faulty insulators

The high field on the first good insulator after a low resistance insulator may be detected by an increase in corona using the corona camera and an increase in the temperature of the insulator above ambient using an infrared camera (about 3-5 ÷C above ambient). For SP AusNet the definitive confirming test (method 1) is to wash the insulators and then measure and plot the voltage across each one. The voltage curve should be fairly smooth (see Figure 6) and evenly distributed for insulators in good condition. If the corona camera and infrared camera detect a problem on a glass insulator it is almost certainly pollution problem.

If a corona camera and an infrared camera detect a high field on a porcelain string it may be caused by adjacent faulty insulators or by pollution. Very high intensity corona on one or two insulators is more likely to indicate faulty insulators causing a highly distorted electric field (see Figure 7 and Figure 8). Whereas pollution is more likely to produce a symmetrical situation i.e. light corona on many strings on the tower especially at the live end. Visual inspection with high- magnification stabilised binoculars can help identify a high pollution situation. The infrared image shown in Figure 9 is of an insulator string with two bottom units having low resistance with cracks in the porcelain. The bottom unit has a “hot” metal cap probably due to resistance heating through the body of the porcelain. The second unit is “cold” with a low resistance crack though the porcelain. The third unit is in good condition and has lower surface heating due to surface leakage currents created by the strong electrical field.

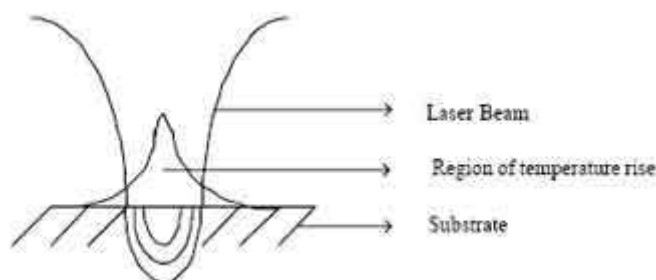
Fig 1: Heat treatment with laser

The interaction mechanisms between laser light and matter depend on the parameters of the laser beam and the physical and chemical properties of the material. Laser parameters are the wavelength, intensity, spatial and temporal coherence, polarization and the angle of incidence. The material is characterized by its chemical composition and microstructure which determine the type of elementary excitations and the interactions between them. Conventional laser processing is mainly performed with IR laser light. This can excite the free electrons within the metal or vibrations within the insulator. In general the excitation energy is dissipated in the form of heat within a time which is short in comparison to any other time involved in the process. As a consequence with low and medium intensities, the laser beam can just be considered as a heat source which induces a temperature rise on the surface and the bulk of the material [13, 14, 15]. This is schematically shown in Fig. 1.

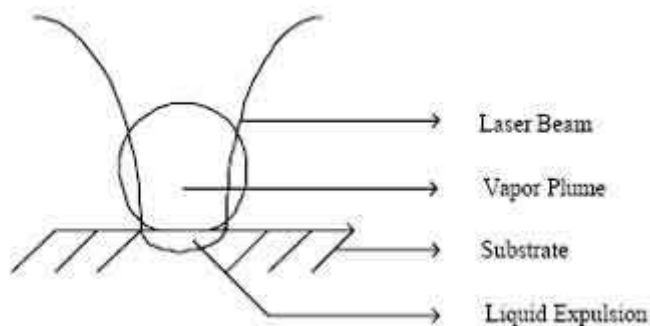
Fig 2: Heat treatment of the material with laser ($I > I_v$)

The temperature distribution is determined by the thermal and optical properties of the material. When the laser intensity (I) reaches a critical value (I_v) beyond which there is a significant material vaporization, a vapor plume is formed as shown in Fig. 2.

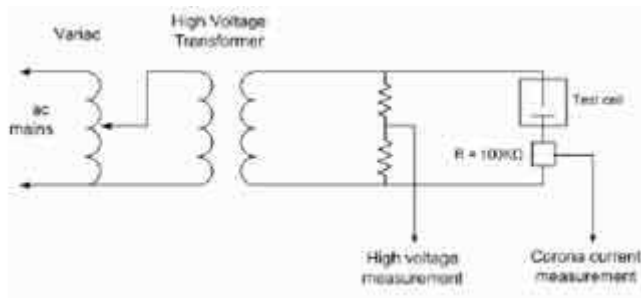
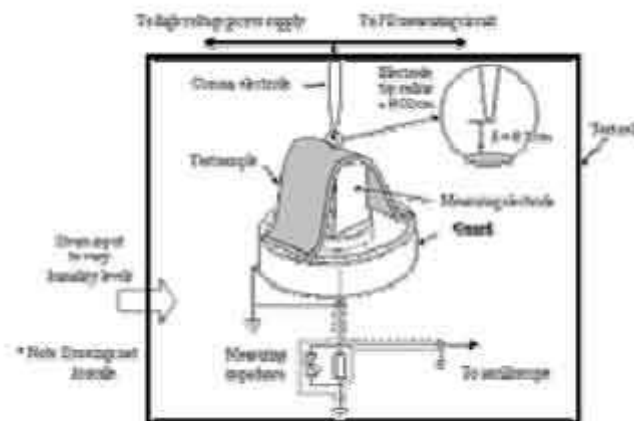
fig 3 a

Figure 3. Experimental setup to access corona performance

A silicone rubber sample was subjected to corona exposure for 500 hours. A brass rod with a point tip (approximately 0.02 cm) energized by an ac voltage served as the corona source (point-plane electrode configuration). The electrode arrangement was

enclosed in an acrylic chamber with dimensions 45cm x 45cm x 120cm. Corona activity was monitored by using an oscilloscope (Tektronix model 540C) and a corona camera. Corona induced degradation was quantified by visual changes on the material surface, optical microscopy, FTIR spectroscopy and laser treatment techniques. The FTIR spectroscopic analysis was performed with a Nicolet Magna-IR 560 spectrometer equipped with an ATR device (spectra-tech model PN-0048). The corona test setup is shown in Fig. 3.

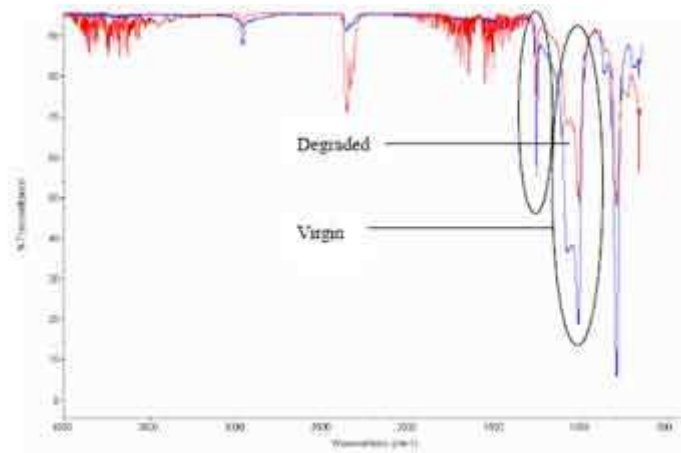
Figure 4. FTIR s spectrum of the sample before/after corona exposure

The absorption peaks corresponding to wave-numbers 1010 cm^{-1} [Si-O-Si] and 1376 cm^{-1} [-CH₃] are used as indicators for degradation. It is clear from Fig. 4 that the corona exposed region has deteriorated significantly.

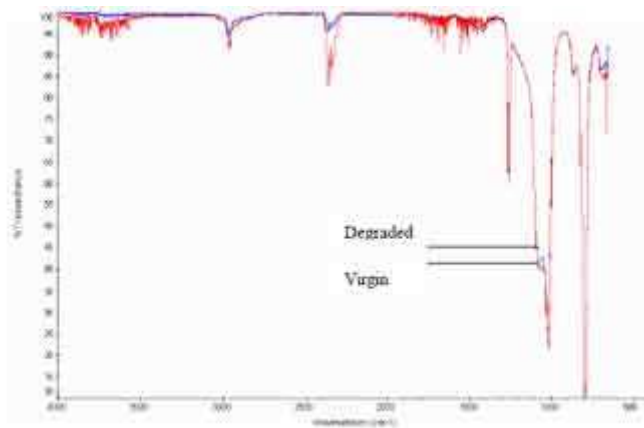
Figure 5. FTIR spectrum of the sample before/after corona exposure and recovery

The FTIR spectroscopy is a surface analysis technique. The depth/region of analysis is limited to a few microns below the sample surface. The silicone rubber material is known to regenerate /recover with time by diffusion of low molecular weight polymer chains to the surface. The technique is hence unsuitable for quantifying changes in the bulk of the material. The recovery effect in silicone rubber is shown in Fig. 5. The absorption peaks corresponding to Si-O-Si and -CH₃ are identical unlike the earlier case shown in Fig. 4.

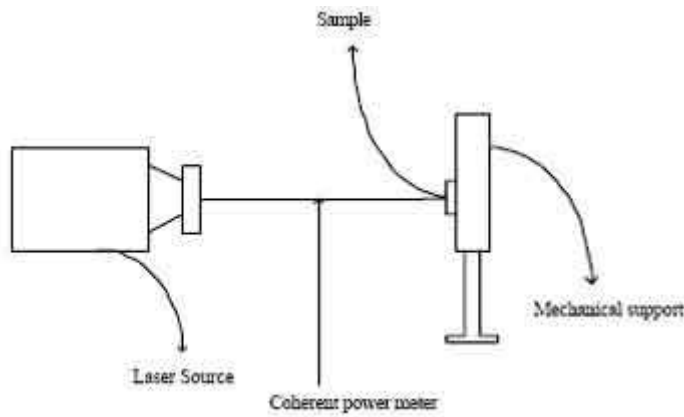
Figure 6. Experimental setup for laser experiments to characterize degradation

The corona exposed region and the virgin sample were treated with a 1.75 watts 532 nm double YAG laser radiation for a constant time (120 seconds). The experimental setup for laser treatment is shown in Fig. 6.

The laser power is measured by using a coherent power meter. The coherent meter is based on the principle of photodiodes. Each photon within the wavelength range of the device creates an electron hole pair. When reverse biased, the electron-hole pair generated results in a current flow that is proportional to the light flux. To obtain the best results the meter should be held perpendicular to the path of the laser beam. To enable measurements over a broad range of wavelengths, power levels, pulse energies and repetition rates multiple sensors can be used.

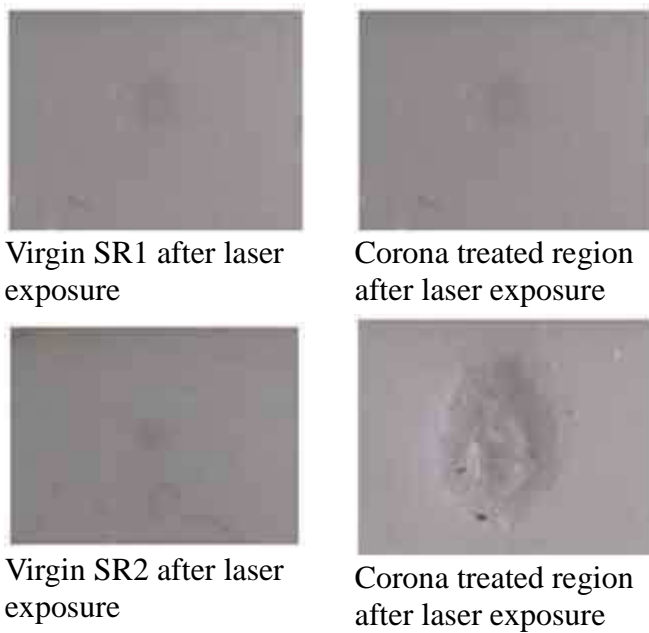
Fig 7: Depth of penetration as a function of degradation

Literature search shows that the depth of penetration in the material is a function of bond strength and concentration. The results reported in Table. 2 and Fig. 7 are in agreement with the theoretical conclusions. FTIR results in Fig. 4 clearly indicated a lower bond concentration and laser treatment results show a greater depth of penetration in the corona exposed region

SN	Sample	Depth of Penetration (inch)
1	Virgin silicone rubber 1 (SR1)	Negligible
2	Virgin silicone rubber 2 (SR2)	Negligible
3	Corona treated SR 1	0.065
4	Corona treated SR 2	0.049

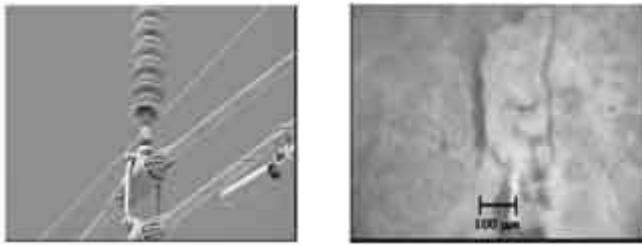
Figure 8. Corona induced degradation on a NCI (20 years field service)

A series of field inspections were conducted in the Phoenix metropolitan area to inspect corona occurrence on in-service insulators. An insulator (20 years field service) subjected to considerable discharge activity while in service was removed for research/experimental purposes. Corona cuts were observed on the underside of the first shed as shown in Fig. 8.

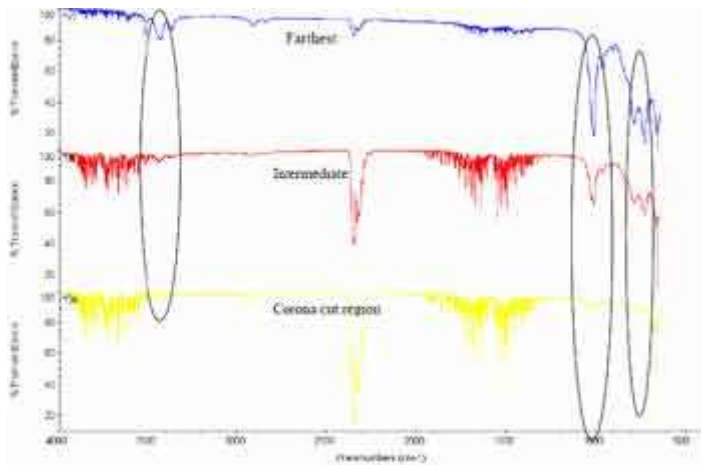
Fig 9: FTIR spectrum as a function of distance from the corona cut region

A sample was cut from the shed closest to the high voltage end and FTIR analysis was performed. The region closest to the corona cut showed the maximum degradation and a decreasing trend was observed with increasing distance from the corona cut region as shown in Fig. 9.

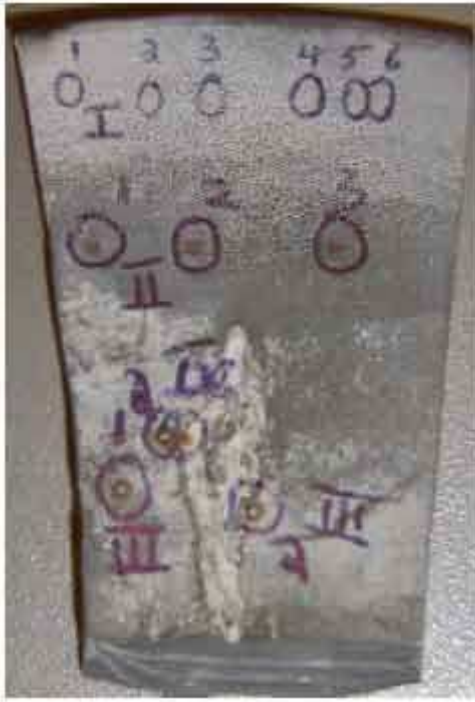
Fig 10: Laser induced changes along the first shed indicated by the circles numbered 1-6

Samples from different sheds (1, 2, 3, 5, and 17) were treated with the 532 nm double YAG laser beam at 1 watt power level. The time of laser exposure was held constant (60 seconds). Samples from second shed and beyond showed little (in the form of discoloration) to no difference after laser treatment. However changes were observed along the first shed as a function of distance from the degraded region. The laser induced visual changes on the first shed is shown in Fig. 10.
